Project:

ESP Structure Lift

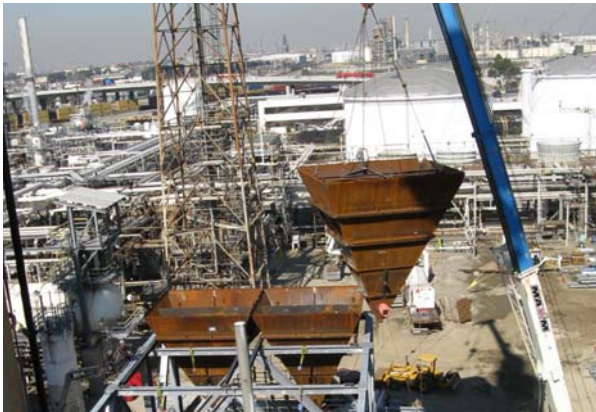
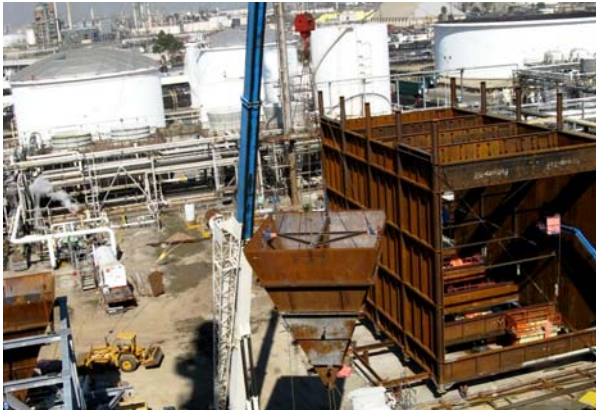
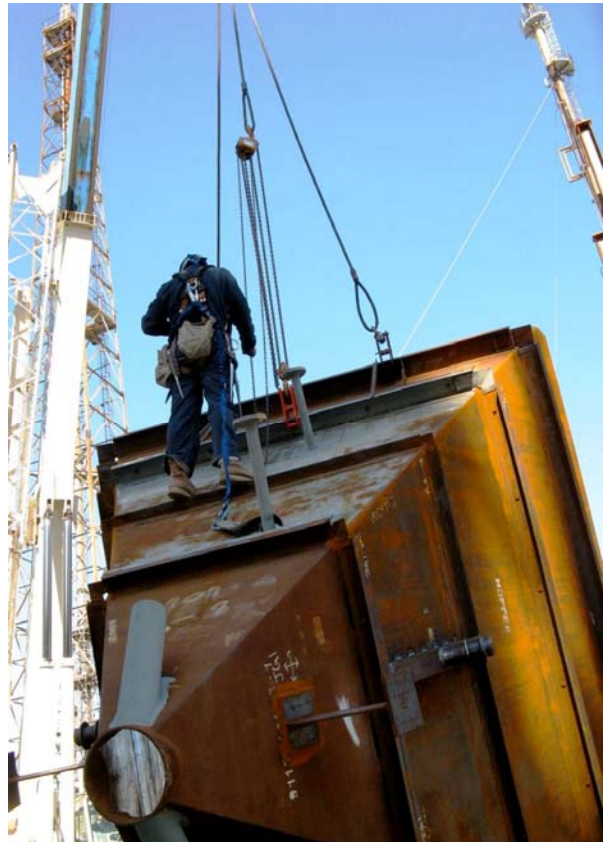
These ESP main box and hoppers were constructed independently; assembly of the unit required the components be properly oriented and lifted into their final location. The precipitator box walls (lower left photo) were constructed one on top of the other and needed to be rotated into an upright position and stabilized with internal bracing. Hoppers were constructed with the cone tip pointing upward and needed to be rotated 180° and lowered into the steel frame bays provided for their support (as seen in the upper left photo). Once the hoppers were in place, the fully assembled precipitator box was placed atop the steel frame and hoppers. The lifting of these structures was challenging due to their thin walls and tendency to flex/warp. It was crucial that the structures not be damaged during lifting and assembly.

Our engineering team fit the precipitator box with additional top beams for lifting lug attachments. By using these beams, the concentrated lifting load was more evenly distributed throughout the structure and warping of the walls was prevented. To prevent warping of the hoppers, a lifting frame was designed to fit within the hopper; this frame was reused for each of the eight individual hopper lifts. This resulted in an efficient and cost effective solution for our client.
